**Controlled flight into terrain
11 km south-east of Kokoda Airstrip
Papua New Guinea
11 August 2009
P2-MCB
De Havilland Canada DHC-6-300**

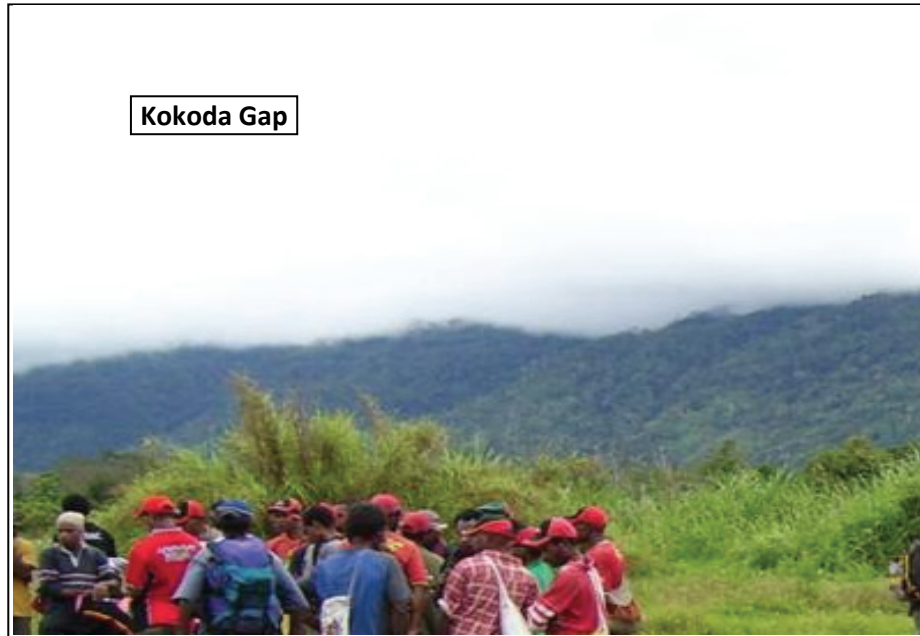
At about 1115, the Kokoda agent telephoned the operator's operation's centre and advised staff that 'the weather was very bad [at Kokoda].' A photo that was taken at Kokoda Airstrip looking toward the Kokoda Gap at about the time of the accident showed the Kokoda Gap completely obscured by cloud (Figure 6). A comparative photograph of the Kokoda Gap on a good weather day is at Figure 7.

Figure 6: View from Kokoda airstrip at about the time of the accident, showing the Kokoda Gap obscured by cloud

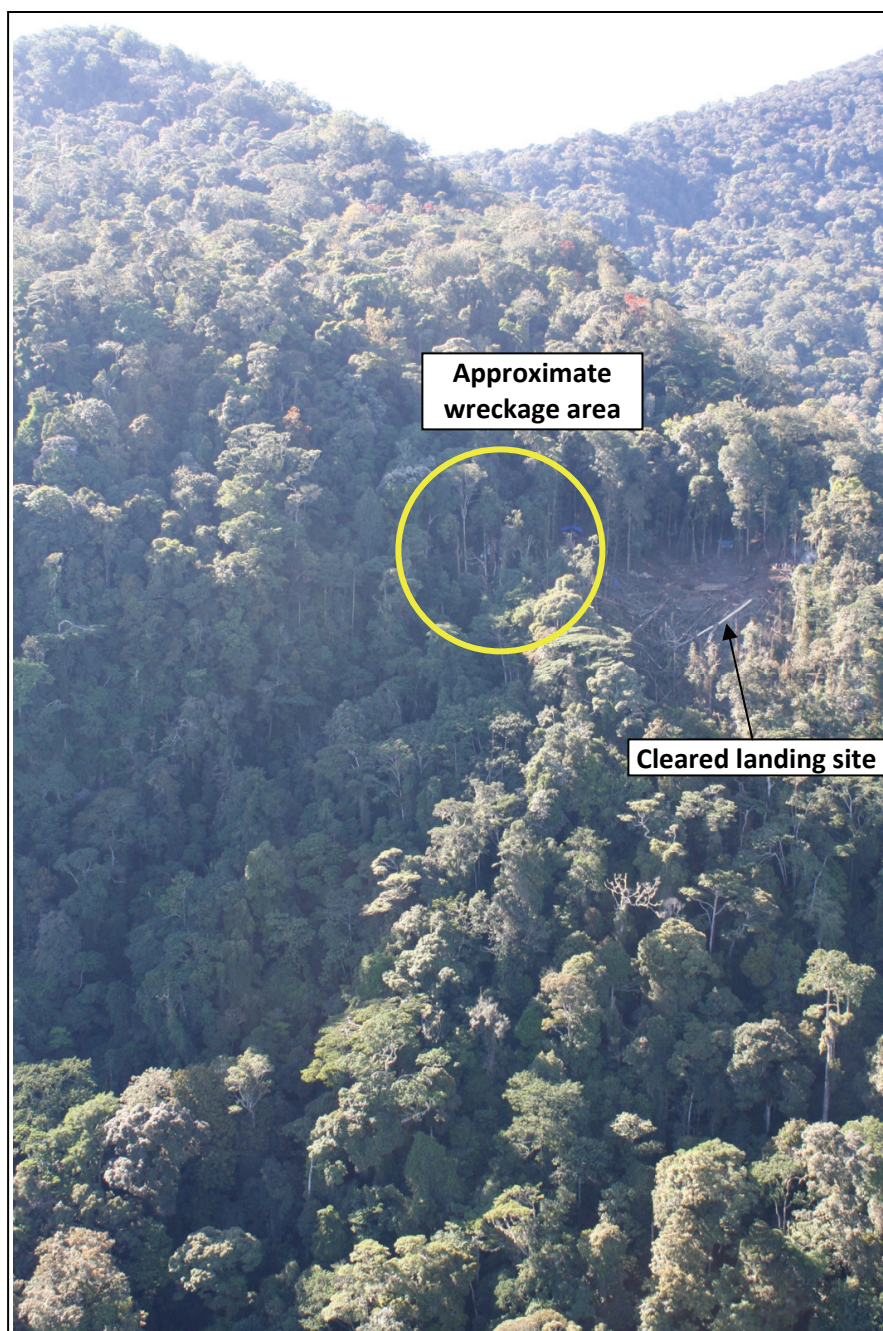
Figure 9: Accident site and terrain

The accident site was located at an elevation of about 5,780 ft (1,760 m) on the eastern side of the Kokoda Gap. The terrain to the east of the accident site continued to rise for about another 1,000 ft to the top of the ridge line. The wreckage trail was oriented on heading of about 110° M and extended for about 100 m on a slope of about 45° up to the horizon in heavily-timbered terrain (Figure 9).

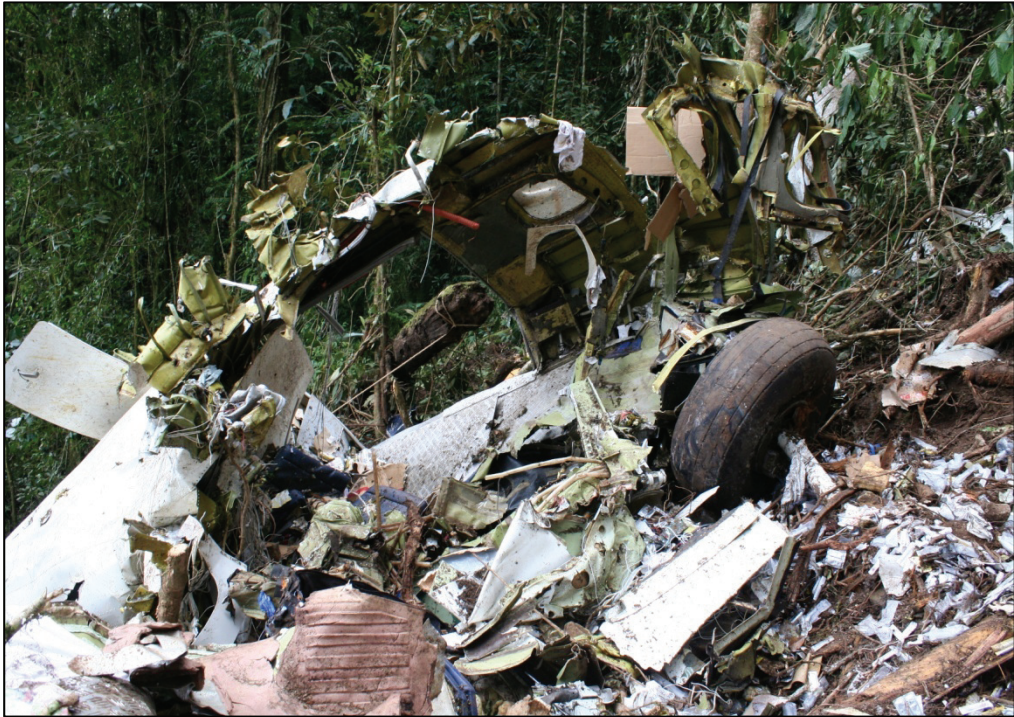
Figure 10: Forward section of the fuselage

The severe airframe disruption was consistent with multiple high-energy impacts with the trees and terrain during the impact sequence (Figure 10). There was no evidence of pre-impact structural failure. All of the flight controls were identified at the accident site; however, the flight control deflection angle prior to the collision with terrain could not be determined.

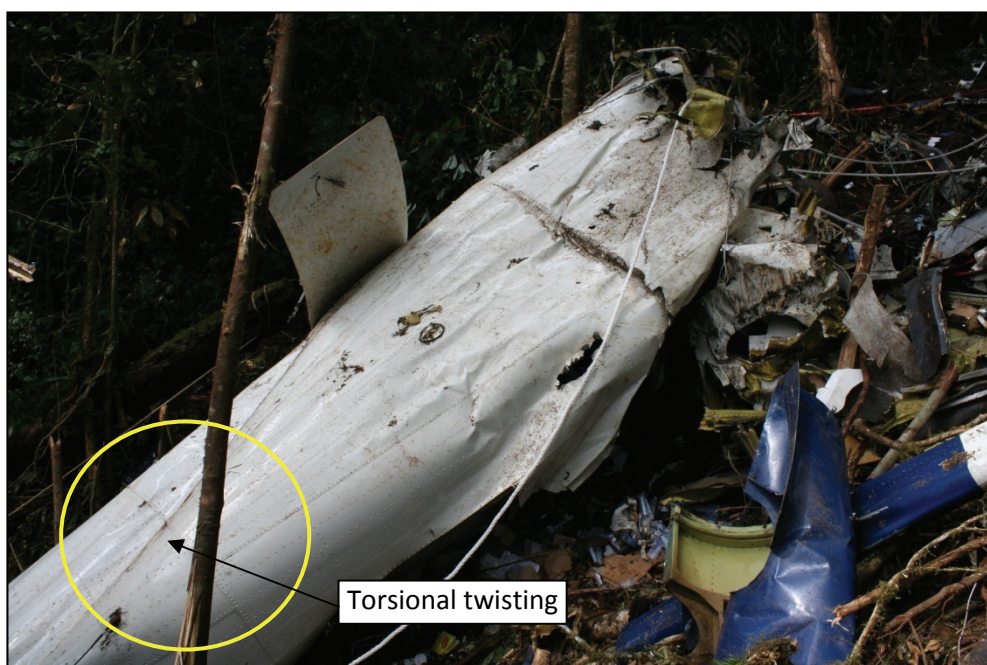
Figure 11: Aft section of the main fuselage showing torsional twisting

The aft section of the main cabin between the empennage and the cargo bay, displayed evidence of torsional twisting (Figure 11). The cargo bay remained intact.

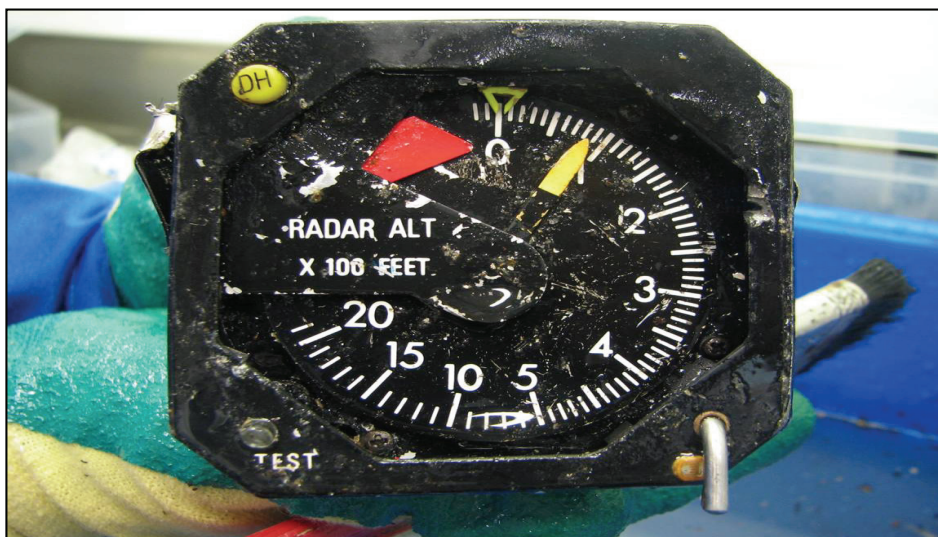
Figure 12: Radar altimeter instrument

An examination of the aircraft's radio altimeter (RADALT) indicator determined that at impact, the pointer was captured at the 80 ft (24 m) position and that the decision height 'bug'²³ was set to 0 ft (Figure 12).

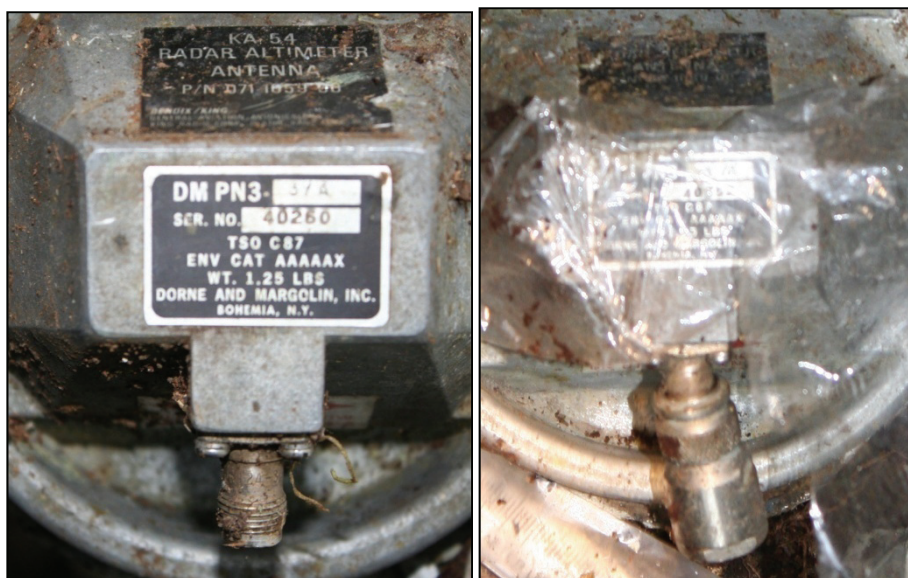
Figure 13: Radar altimeter antennas

The aircraft had two RADALT antenna's (transmitter and receiver). One antenna cable connector was found attached, although the cable had separated from that connector. The other antenna's cable connector was not attached to the antenna.

Further examination determined that the antenna cable connector had been torn from the antenna as a result of the impact forces (Figure 13).

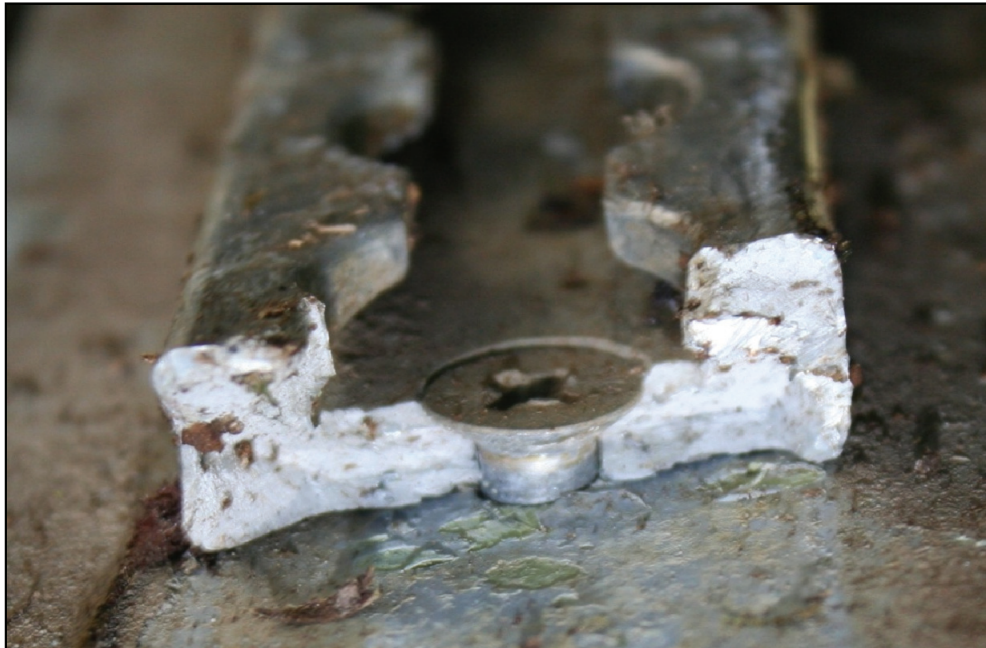
Figure 14: Exemplar overload failure of seat track

The seat track sections that secured the seats to the cabin floor were found throughout the accident site. The track fracture surfaces of those seats were examined and were consistent with overload-type failures (Figure 14).

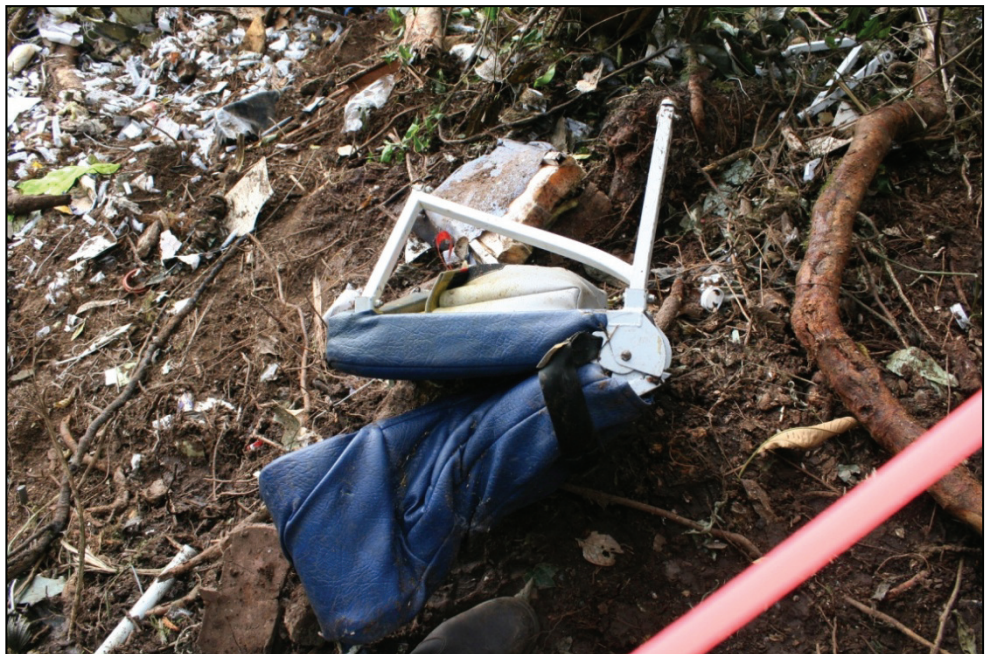
Figure 15: Distorted passenger seat with seat belt attached

The aircraft's seats and seat belts were also examined. The majority of the seats were distorted and disrupted (Figure 15). Some of the still-complete seat belts remained attached to their seat frames and were undone. The Disaster Victim Identification team confirmed that they had undone a number of seat belts during their on-site activities. The investigation could not establish if all of the passengers had their seat belts secured at the time of impact.
